**Flood Control Project Maintenance
Levee Inspections****LMA District Cover Sheet
Spring 2015 Levee Inspection Results****Reclamation District No. 2101 Blewett**

Spring 2015 Levee Inspection Results

Reclamation District No. 2101 Blewett

Waterway			Bank	Unit Miles
Unit No. 01 San Joaquin River			Left	3.16
	Spring (March - May)	Summer (June - August)	(September - November) Fall	Winter (December - February)
Unit Maintenance Rating (Fall Only)				
Date of Inspection	03/26/2015 - 03/26/2015			
DWR Inspector	Maksim Khashchuk			
Accompanied By

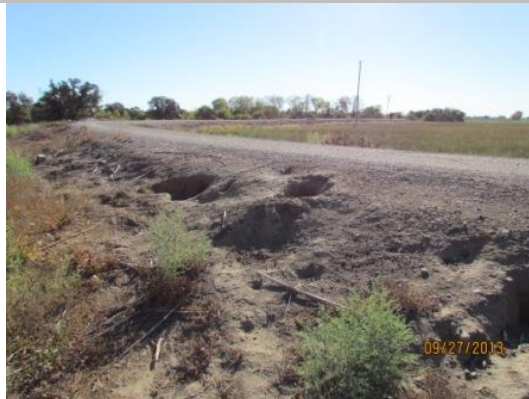
Photo 1 of 1 : SP_2015_RD2101_326_12_20150317_00005.jpg

LM Start	0.04	Rating **	M	Issue No.	12
LM End	0.04	Issue Type +	Ma	Location *	WS
Category	Earthen Levee			GPS Latitude/Longitude	
				Start	End
Item	Animal Control			37.657648 °	37.657648 °
				-121.253812 °	-121.253812 °
DWR ID	DWR_RD2101_01_s_2012_12				
Action/Comments					
No rodents visible, but rodent burrows visible; need to backfill and compact or grout burrows.

View of rodent holes on waterward slope, facing upstream.

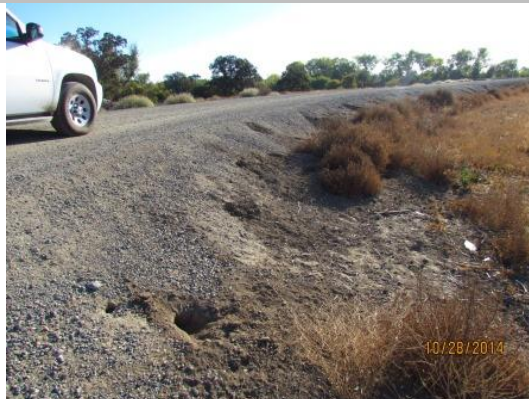
Photo 1 of 1 : SP_2015_RD2101_326_16_20150317_00007.jpg

LM Start	0.08	Rating **	M	Issue No.	16
LM End	0.08	Issue Type +	Ma	Location *	LS
Category	Earthen Levee			GPS Latitude/Longitude	
				Start	End
Item	Animal Control			37.657811 °	37.657811 °
				-121.253269 °	-121.253269 °
DWR ID	DWR_RD2101_01_s _ 2013_16				
Action/Comments					
No rodents visible, but rodent burrows visible; need to backfill and compact or grout burrows. Inspector Comments: Continue rodent extermination and backfilling the rodent burrows.

View of rodent burrows on the landside levee slope.

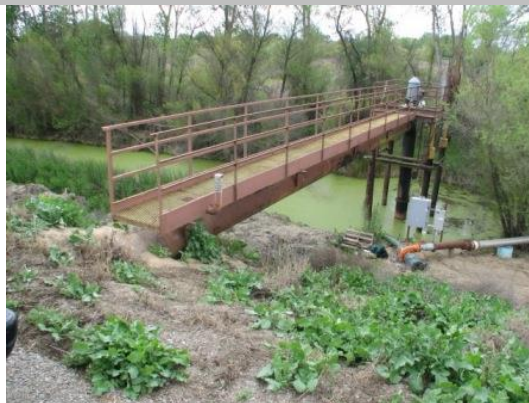
Photo 1 of 1 : SP_2015_RD2101_326_7_20150317_00003.jpg

LM Start	0.20	Rating **	A/W	Issue No.	7
LM End	0.20	Issue Type +	En	Location *	CR
Category	Earthen Levee			GPS Latitude/Longitude	
				Start	End
Item	Encroachments			37.657128 °	37.657128 °
				-121.251692 °	-121.251692 °
DWR ID	DWR_RD2101_01_s _ 2012_7				
Action/Comments					
Pipe

Drainage discharge under levee crown.

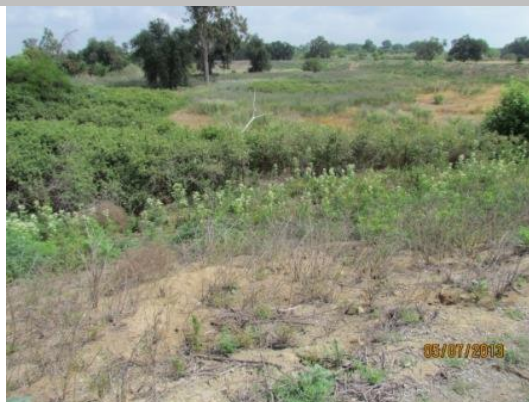
Photo 1 of 1 : SP_2015_RD2101_326_26_20150317_00012.jpg

LM Start	0.70	Rating **	M	Issue No.	26
LM End	0.70	Issue Type +	Ma	Location *	WS
Category	Earthen Levee			GPS Latitude/Longitude	
				Start	End
Item	Animal Control			37.659907 °	37.659907 °
				-121.244219 °	-121.244219 °
DWR ID	DWR_RD2101_01_s_2013_26

View of the rodent burrows on the waterside levee slope.

Action/Comments					
Exterminate rodents and backfill and compact or grout burrows.

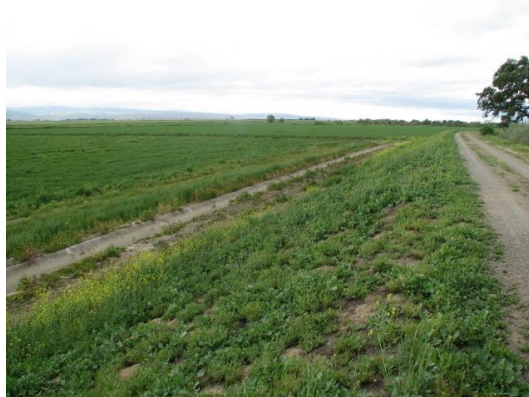
Photo 1 of 1 : SP_2015_RD2101_326_944_20150317_00019.jpg

LM Start	0.73	Rating **	M	Issue No.	944
LM End	1.76	Issue Type +	En	Location *	LS
Category	Earthen Levee			GPS Latitude/Longitude	
				Start	End
Item	Encroachments			37.659827 °	37.651049 °
				-121.243675 °	-121.231475 °
DWR ID	DWR_RD2101_01_s_2012_944				
Action/Comments					
Ditch

Concrete ditch near landside toe.

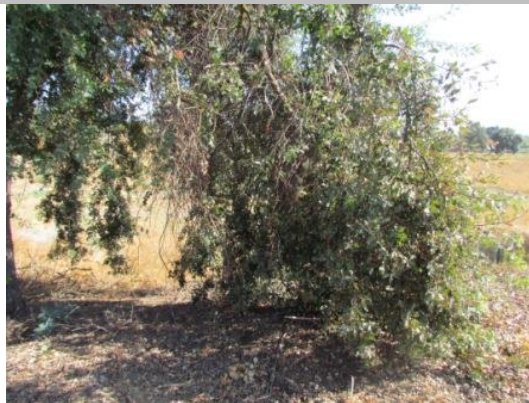
Photo 1 of 1 : SP_2015_RD2101_326_11_20150317_00004.jpg

LM Start	0.75	Rating **	M	Issue No.	11
LM End	0.75	Issue Type +	Ma	Location *	WS
Category	Earthen Levee			GPS Latitude/Longitude	
				Start	End
Item	Trim / Thin Trees			37.659705 °	37.659705 °
				-121.243306 °	-121.243306 °
DWR ID	DWR_RD2101_01_f_2012_11				
Action/Comments					
Trim trees to at least five feet above ground level. Inspector Comments: Trim tree to allow access and visibility.

View of tree branches obstructing waterside slope.

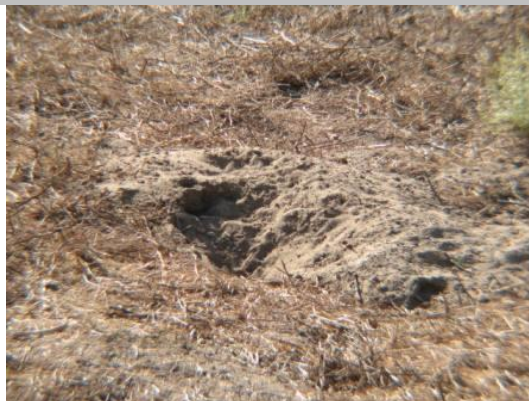
Photo 1 of 1 : SP_2015_RD2101_326_3_20150317_00002.jpg

LM Start	0.87	Rating **	M	Issue No.	3
LM End	0.87	Issue Type +	Ma	Location *	LS
Category	Earthen Levee			GPS Latitude/Longitude	
				Start	End
Item	Animal Control			37.658663 °	37.658663 °
				-121.241750 °	-121.241750 °
DWR ID	DWR_RD2101_01_s_2012_3				
Action/Comments					
No rodents visible, but rodent burrows visible; need to backfill and compact or grout burrows.

11/02/2011 Active rodent burrow.

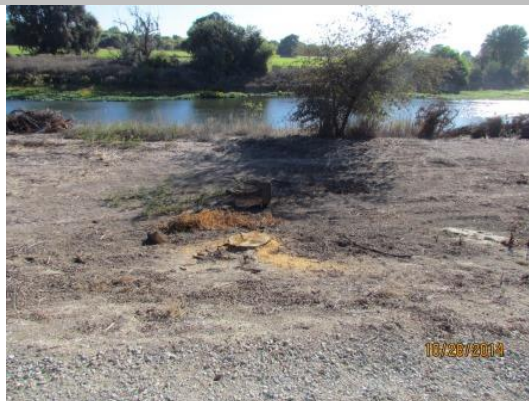
Photo 1 of 1 : SP_2015_RD2101_326_33_20150317_00018.jpg

LM Start	1.02	Rating **	N	Issue No.	33
LM End	1.02	Issue Type +	Ma	Location *	WS
Category	Earthen Levee			GPS Latitude/Longitude	
				Start	End
Item	Trim / Thin Trees			37.656745 °	37.656745 °
				-121.241104 °	-121.241104 °
DWR ID	DWR_RD2101_01_f_2014_33				
Action/Comments					
Tree stumps.

View of the tree stump at the waterside levee toe.

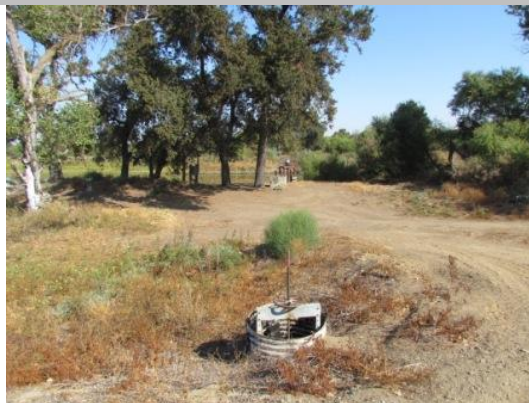
Photo 1 of 1 : SP_2015_RD2101_326_13_20150317_00006.jpg

LM Start	1.59	Rating **	A/W	Issue No.	13
LM End	1.59	Issue Type +	Ma	Location *	WS
Category	Earthen Levee			GPS Latitude/Longitude	
				Start	End
Item	Encroachments			37.651555 °	37.651555 °
				-121.234319 °	-121.234319 °
DWR ID	DWR_RD2101_01_s_2012_13				
Action/Comments					
Pipe					
Inspector Comments: Pipe penetrates through levee. Closure valve on water side slope.

Photo of pump in background and CMP riser with valve in foreground.

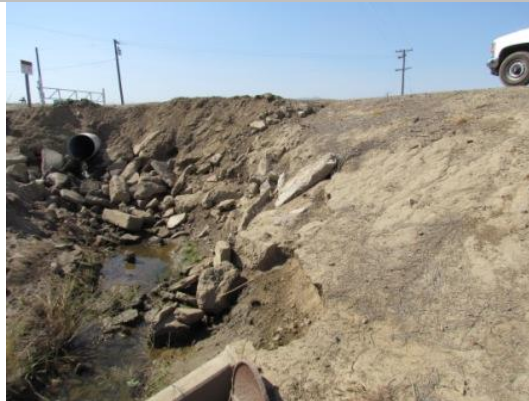
Photo 1 of 2 : SP_2015_RD2101_326_29_20150317_00015.jpg

LM Start	2.87	Rating **	M	Issue No.	29
LM End	2.87	Issue Type +	Ma	Location *	WS
Category	Earthen Levee			GPS Latitude/Longitude	
				Start	End
Item	Erosion / Bank Caving			37.639852 °	37.639852 °
				-121.229980 °	-121.229980 °
DWR ID	DWR_RD2101_01_s _ 2012_29				
Action/Comments					
Schedule repair of erosion site prior to the next inspection.

View of repaired site, but it appears that erosion is still occurring.
09/25/2012

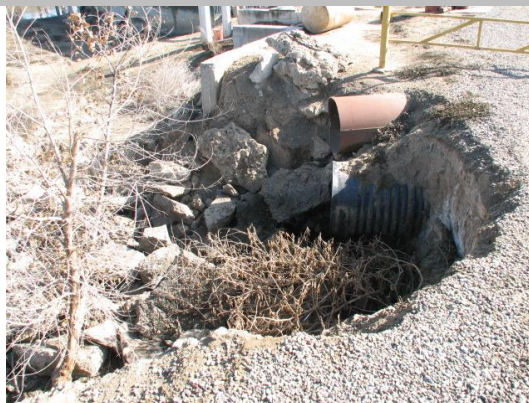
Photo 2 of 2 : SP_2015_RD2101_326_29_20150317_00016.jpg

LM Start	2.87	Rating **	M	Issue No.	29 (cont)
LM End	2.87	Issue Type +	Ma	Location *	WS

Levee slope is being eroded at this location. Repair needed to preserve access road.

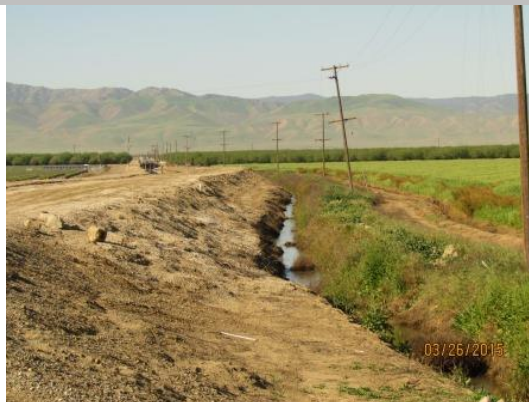
Photo 1 of 1 : SP_2015_RD2101_326_8_20150330_00027.jpg

LM Start	2.88	Rating **	M	Issue No.	8
LM End	3.15	Issue Type +	En	Location *	LS
Category	Earthen Levee			GPS Latitude/Longitude	
				Start	End
Item	Encroachments			37.639780 °	37.637167 °
				-121.230008 °	-121.233715 °
DWR ID	DWR_RD2101_01_f _ 2013_8				
Action/Comments					
Ditch

View of the ditch at the landside levee toe.

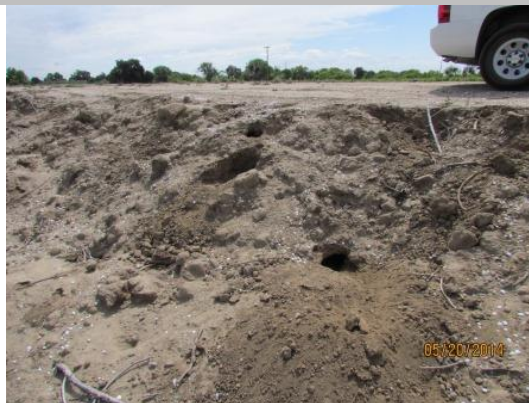
Photo 1 of 1 : SP_2015_RD2101_326_17_20150317_00008.jpg

LM Start	2.98	Rating **	M	Issue No.	17
LM End	2.98	Issue Type +	Ma	Location *	LS
Category	Earthen Levee			GPS Latitude/Longitude	
				Start	End
Item	Animal Control			37.638760 °	37.638760 °
				-121.231341 °	-121.231341 °
DWR ID	DWR_RD2101_01_s_2012_17				
Action/Comments					
Exterminate rodents and backfill and compact or grout burrows. Inspector Comments: Active burrows with rodents present.

Numerous burrows present, some already caving in, others are active.

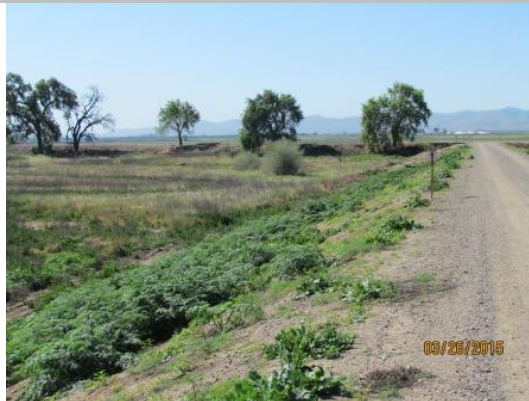
Photo 1 of 1 : SP_2015_RD2101_327_1_20150330_00003.jpg

LM Start	0.10	Rating **	M	Issue No.	1
LM End	0.10	Issue Type +	Ma	Location *	WS
Category	Earthen Levee			GPS Latitude/Longitude	
				Start	End
Item	Vegetation			37.661185 °	37.661185 °
				-121.243088 °	-121.243088 °
DWR ID	DWR_RD2101_02_f_2014_1				
Action/Comments					
Control annual grass and weeds on the levee slopes and easements.

View of the vegetation on the waterside levee slope.

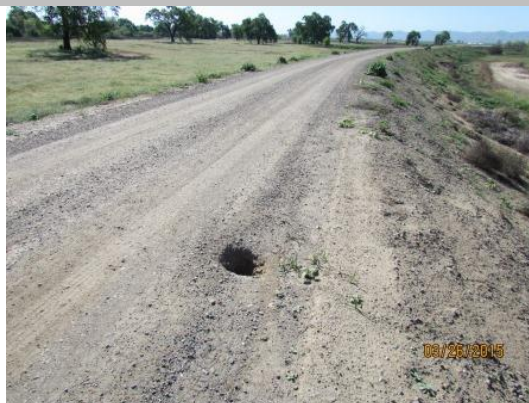
Photo 1 of 1 : SP_2015_RD2101_327_2_20150330_00004.jpg

LM Start	0.23	Rating **	M	Issue No.	2
LM End	0.23	Issue Type +	Ma	Location *	CR
Category	Earthen Levee			GPS Latitude/Longitude	
				Start	End
Item	Animal Control			37.662968 °	37.662968 °
				-121.242674 °	-121.242674 °
DWR ID	DWR_RD2101_02_f_2013_2				
Action/Comments					
No rodents visible, but rodent burrows visible; need to backfill and compact or grout burrows. Inspector Comments: Backfill and compact the rodent holes to restore the levee to original condition.

View of the rodent burrow on the levee crown.
